SCULPTURE MAINTENANCE RECORD

Artist: Tom Gibbs

Title: SONG OF THE EARTH

Location: UCA, Conway

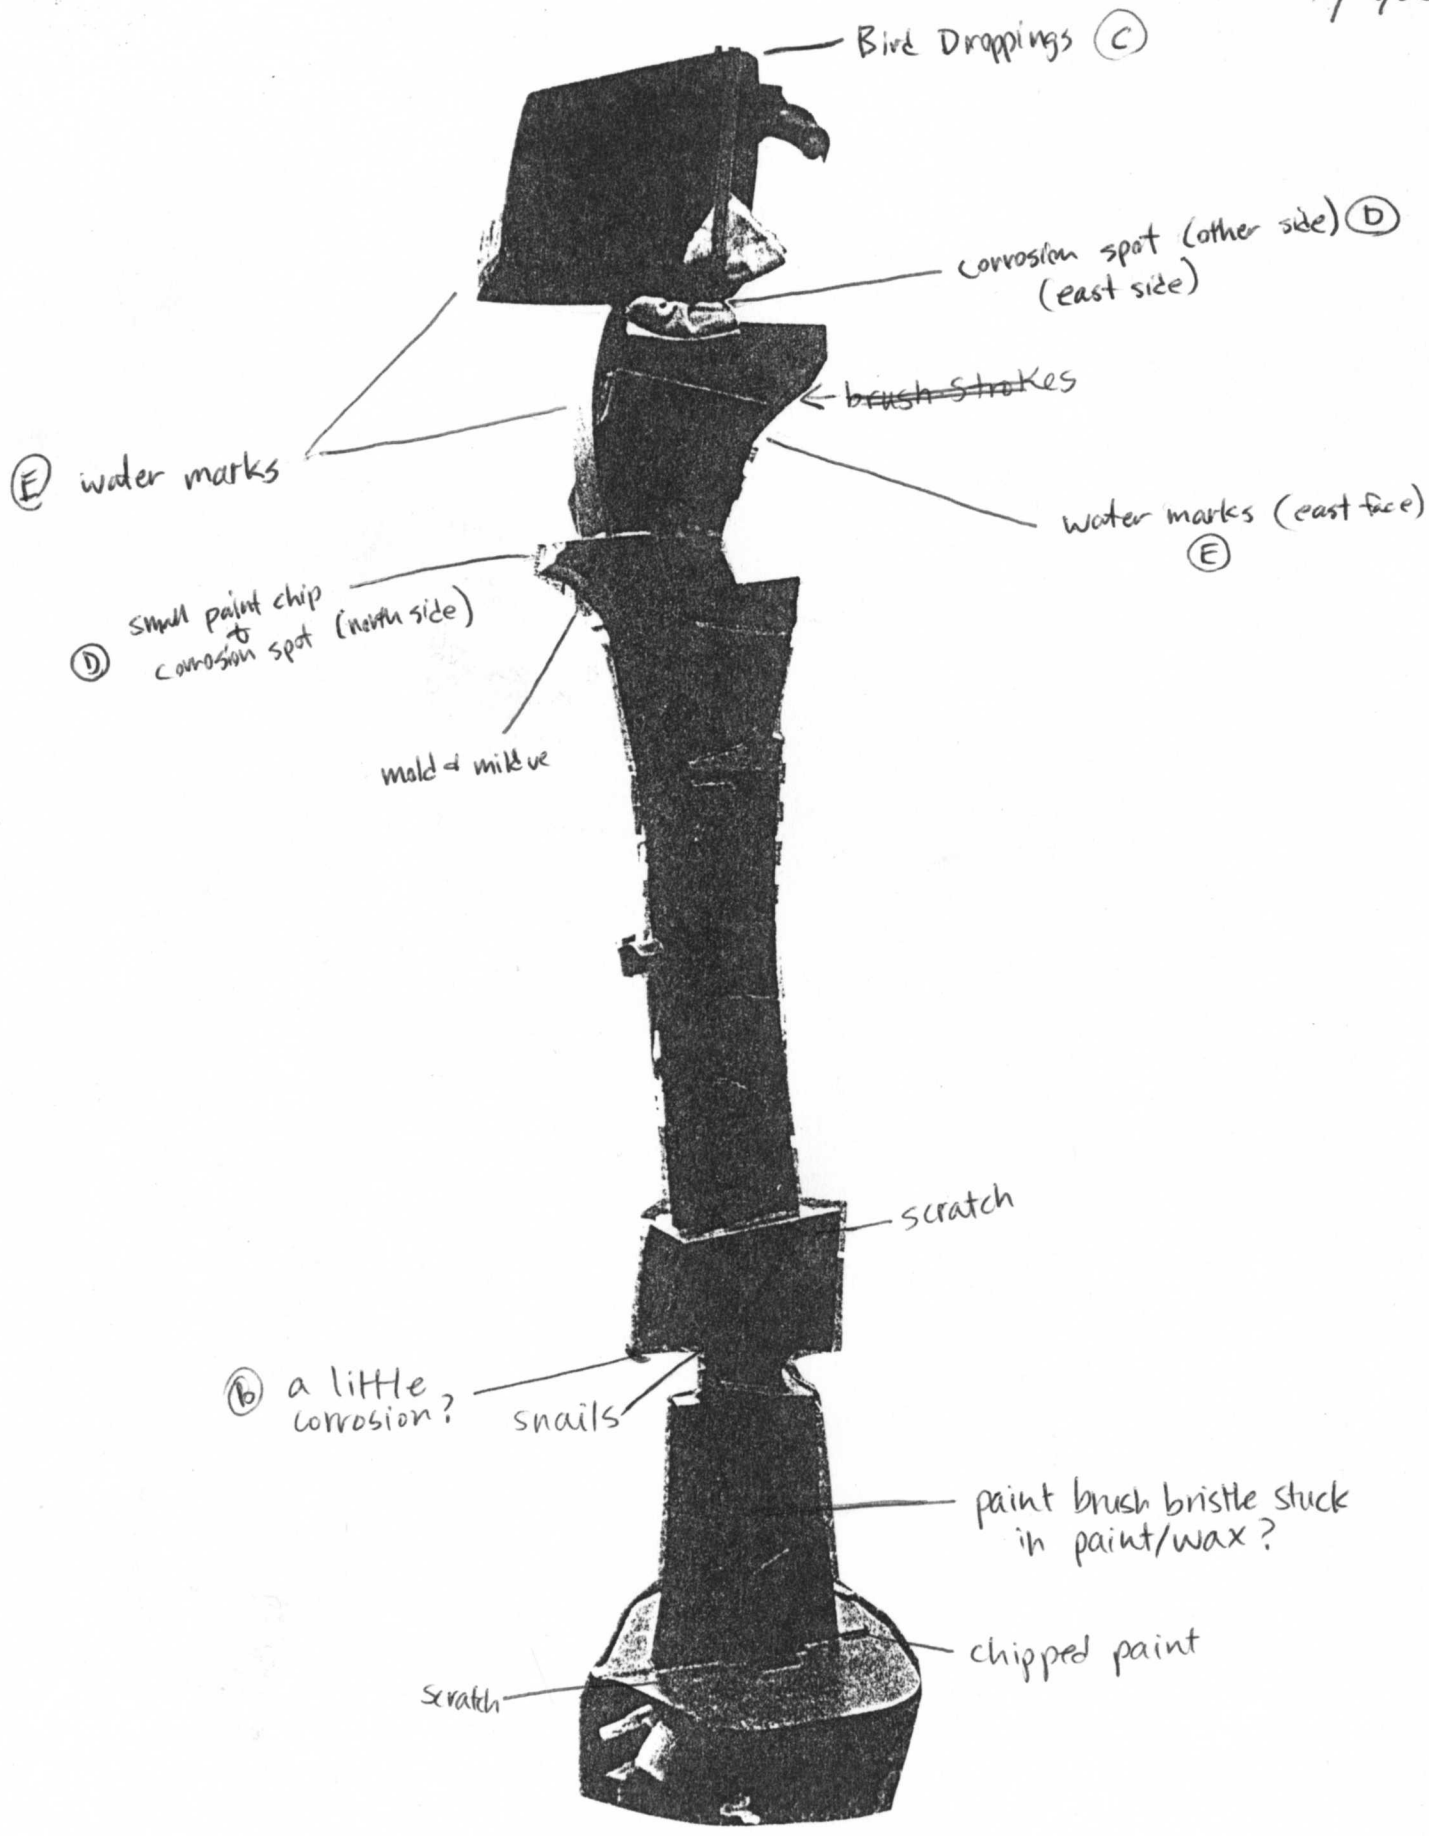
10/16/03

Discoloration (staining, blanching, darkening . . .)
water streaks (E)

possibly @ (B) (D) paint chip + corrosion

(C) - Bird droppings on top

(D) small paint chip

Bird Droppings (C)

corrosion spot (other side) (D)
(east side)

← brush strokes

(E) water marks

water marks (east face)
(E)

(D) small paint chip
& corrosion spot (north side)

mold & mildew

scratch

(B) a little corrosion?
snails

paint brush bristle stuck
in paint/wax?

chipped paint
