SCULPTURE MAINTENANCE RECORD

Artist: Tom Gibbs

Title: SONG OF THE EARTH

Location: UCA, Conway

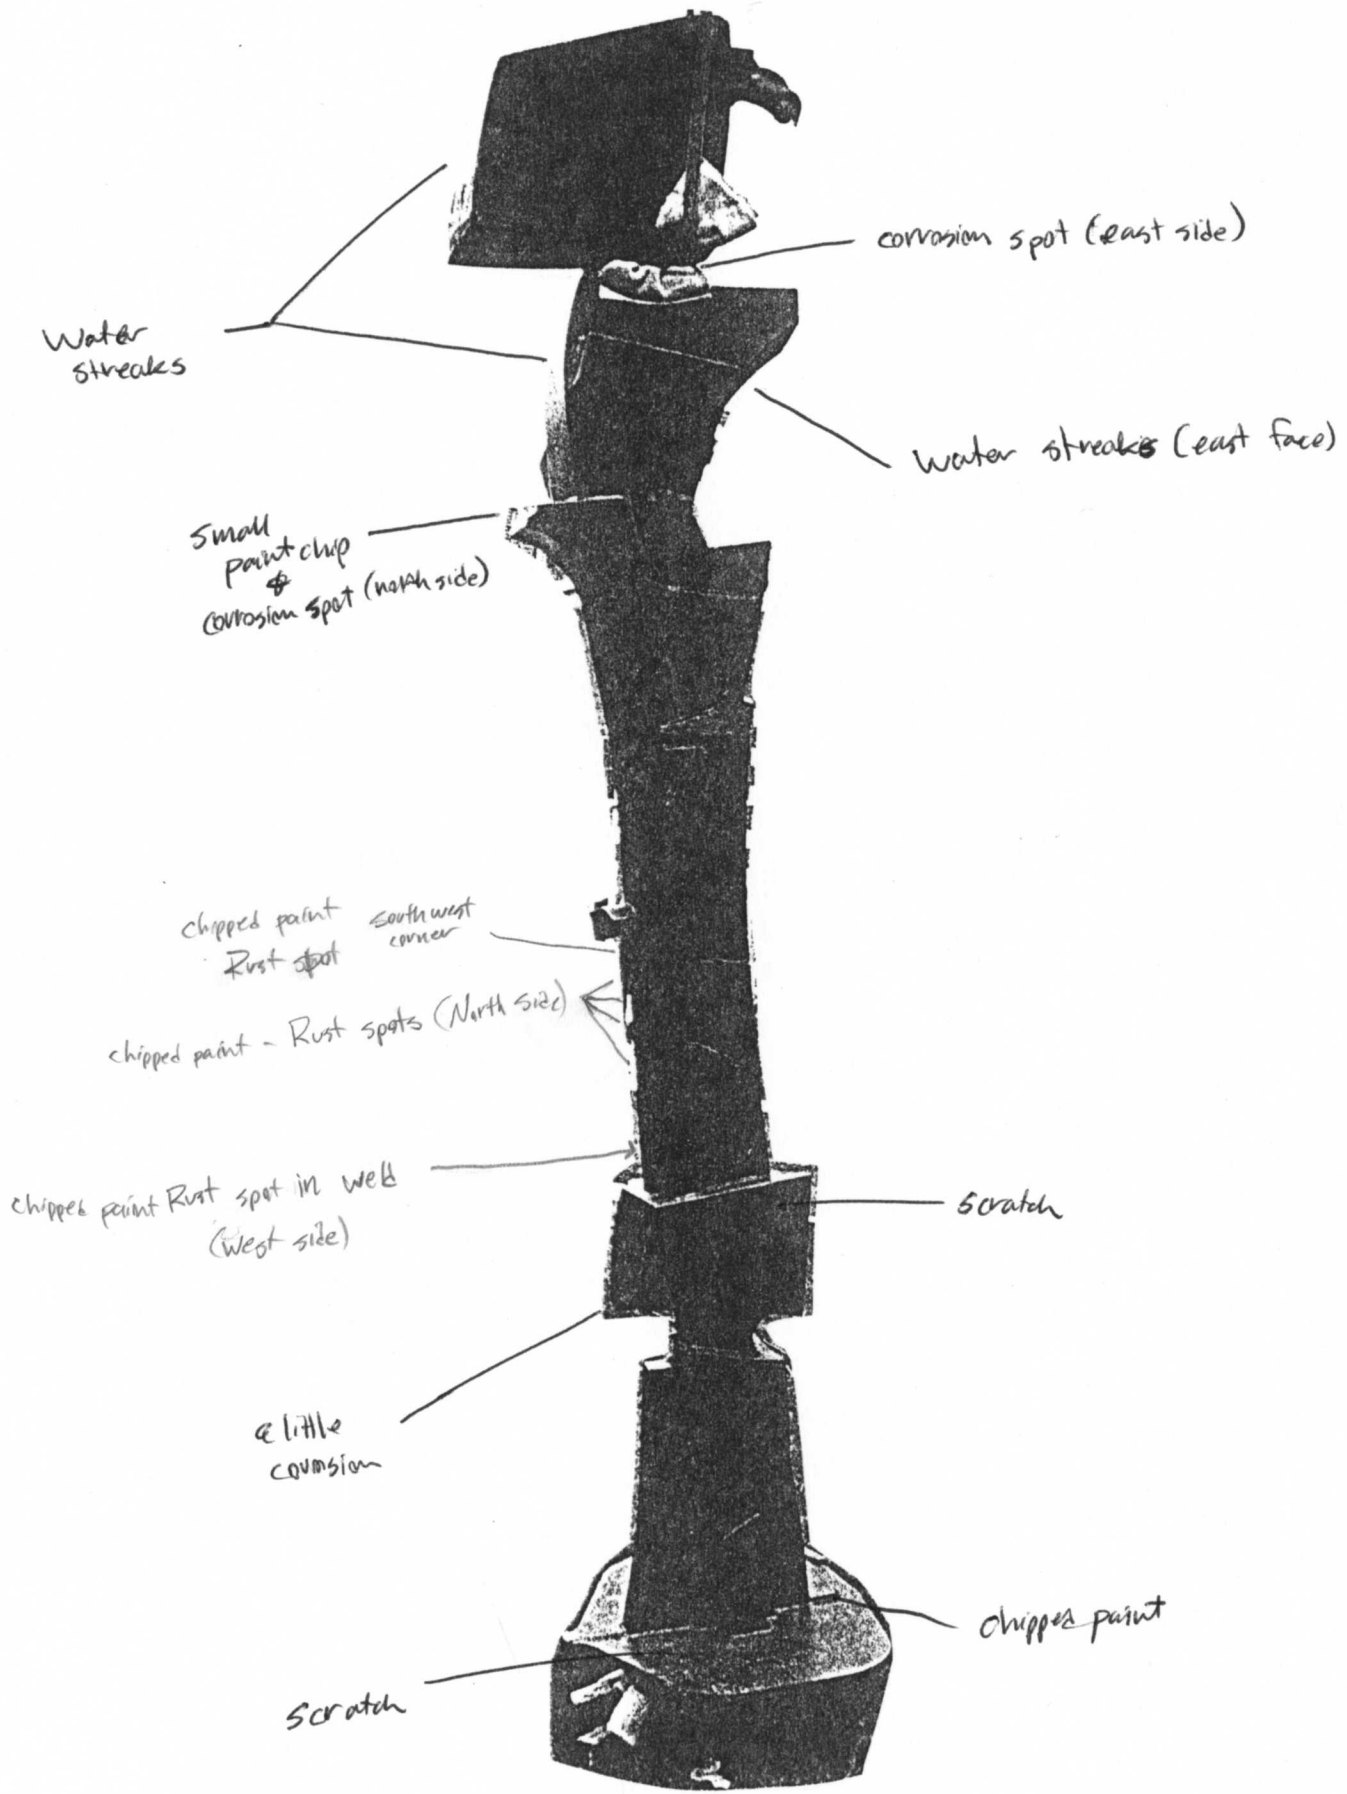
Discoloration (staining, blanching, darkening . . .) Fabric of Sculpture Surface Finish or Applied Patina
water streaks (E) Applied Coating(s)

Corrosion Activity Fabric of Sculpture Surface Finish or Applied Patina Applied Coating(s)
chipped paint & Rust

Physical Damage (worn, abraded, chipped, scratched ...) Fabric of Sculpture Surface Finish or Applied Patina
A few scratches on base, and some chipped paint on base Applied Coating(s)

Other Problems Fabric of Sculpture Surface Finish or Applied Patina Applied Coating(s)
small paint chips

Water streaks

corrosion spot (east side)

Water streaks (east face)

Small paint chip & corrosion spot (north side)

chipped paint Rust spot south west corner

chipped paint - Rust spots (North side)

chipped paint Rust spot in well (west side)

scratch

a little corrosion

chipped paint

Washed (Materials/Method) Sculpture Pedestal
Water and Shuklee Basic #, then a good rinse

Application of Protective Coating (Materials/Method) Sculpture Pedestal
One Coat of Johnson's Paste Wax, then polished (buffed)
