SCULPTURE MAINTENANCE RECORD

Accession Number:			6	Bunnze
Artist:	Tom Gibbs	Title:	SONG OF THE EARTH Cast	Drawe
Location:	UCA, Conway	Component/Mate	erials:	
Dimensions:				
Date Examined: \\/	22/05	By (name): Rold	by Burton	
Date(s) of Maintenance	e Treatment: 11/22/05	By (name): Rold By (name): Rold		
Previous Maintenar (Indicate method and	nce Treatment: none materials used, if known)	☐ maintained (last date	Page 1 of 2	
CONDITION SCULPTURE				
☐ Discoloration (sta	aining, blanching, darkening)	□ Fabric of Sculpture □ □ Applied Coating(s)	Surface Finish or Applied Patina	
□ Graffiti □Fa	ubric of Sculpture Surface	Finish or Applied Patina	☐ Applied Coating(s)	
None			INTENANCE STEPS	
□ Corrosion Activity None	ty □Fabric of Sculpture	☐ Surface Finish or Applied	Patina	
□ Foreign Materials See diagro	s (accretions, bird guano)			
□ Physical Damage Nove	(worn, abraded, chipped, scratc	hed) □Fabric of Sculptur □ Applied Coating(e □Surface Finish or Applied Pati (s)	ina

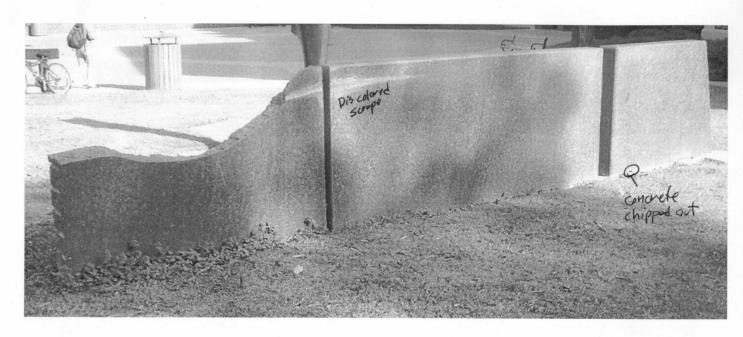
South

AINTENANCE RECORD		Page 2 of 2
Accession Number Artist/Title: Tom Date of Record:	Gibbs/SONG OF THE EARTH	Component:	
CONDITION PEDESTAL	see diagram retening wall seems to separation on the stairs	moving. There is also son	ne
☐ Graffiti	separation on the staur		
☐ Accretions			
☐ Staining			
☐ Mechanical Da			
☐ Cracks			
☐ Problems with	a Joints Frankland E3 avendund to arrow (C3 (e.gourse) beliege E3		
☐ Other Condition	on Problems		
3)	inish or Applied Patins D. Applied Coating()	Disabric of Sculpture Di Surface F	Etherið E
MAINTENANC	CE STEPS		
☑ Washed (Mai	terials/Method) Sculpture Pedestal		
Application of	of Protective Coating (Materials/Method)	☑Sculpture ☑ Pedestal	
☐ Other Mainte	enance Treatment Steps (Materials/Method	d) □Sculpture □ Pedestal

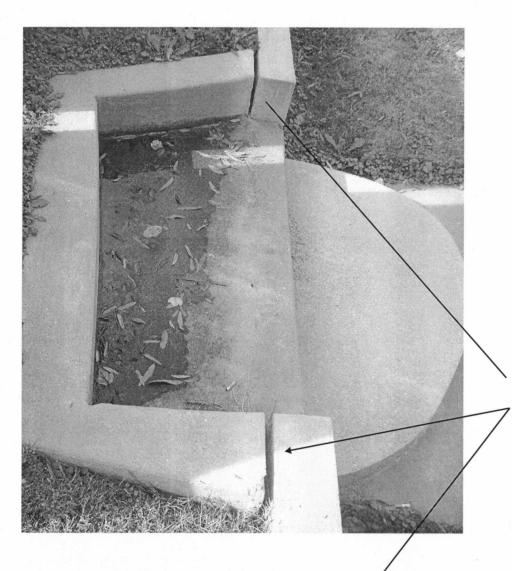
Concrete Separation Nov. 2005
