SCULPTURE MAINTENANCE RECORD

Artist: Tom Gibbs

Title: SONG OF THE EARTH

Location: UCA, Conway

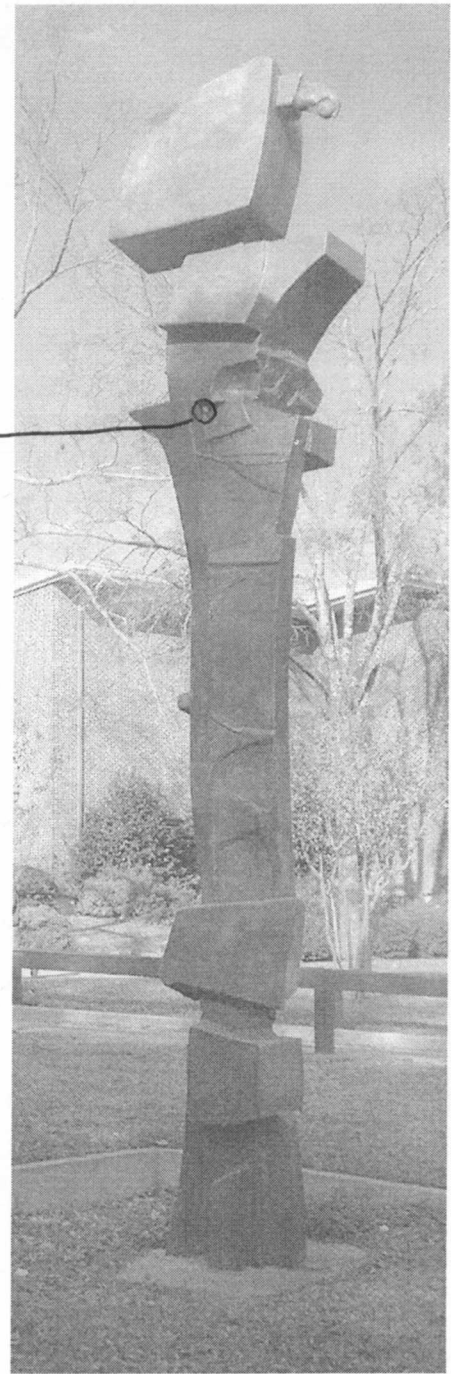
South East

Build up

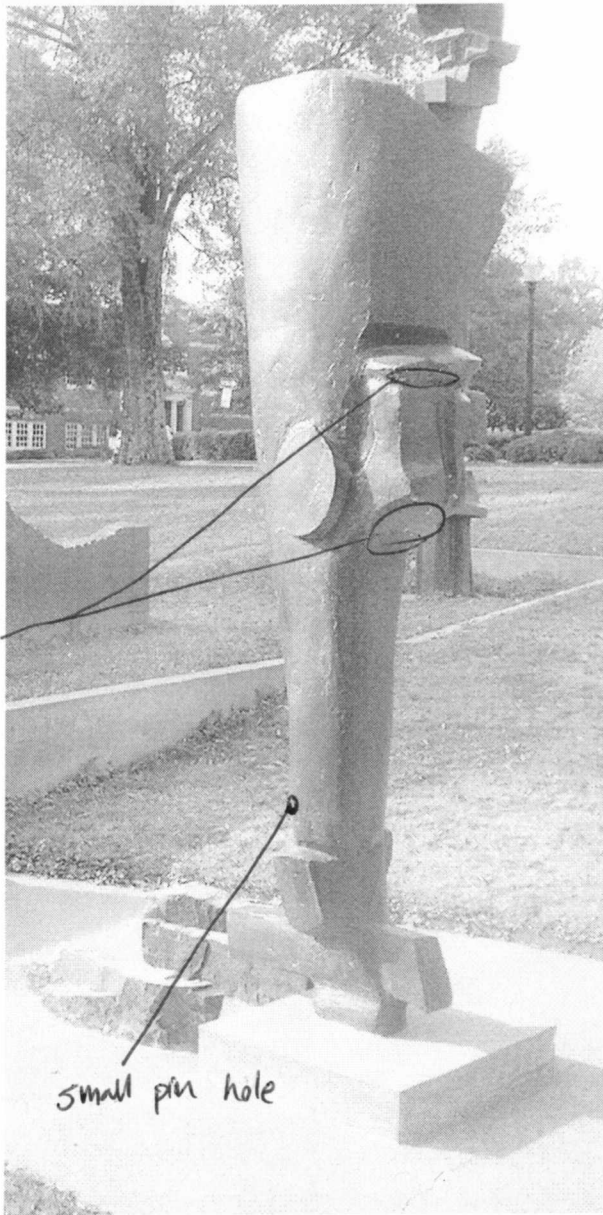
North East

small pin hole

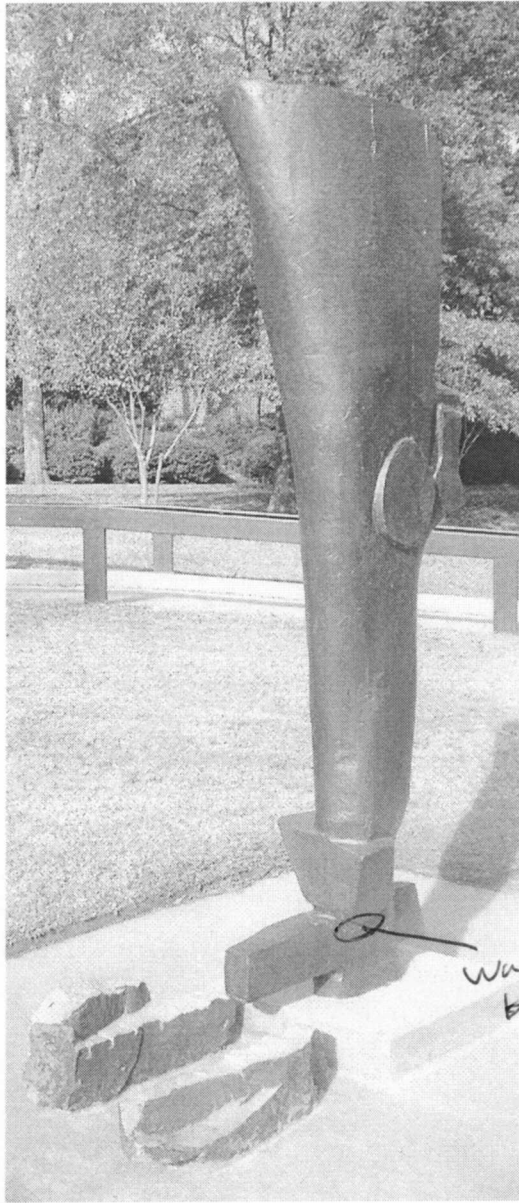
South East

Wax buildup

2 coats of Joushons Paste wax applied, then buffed.

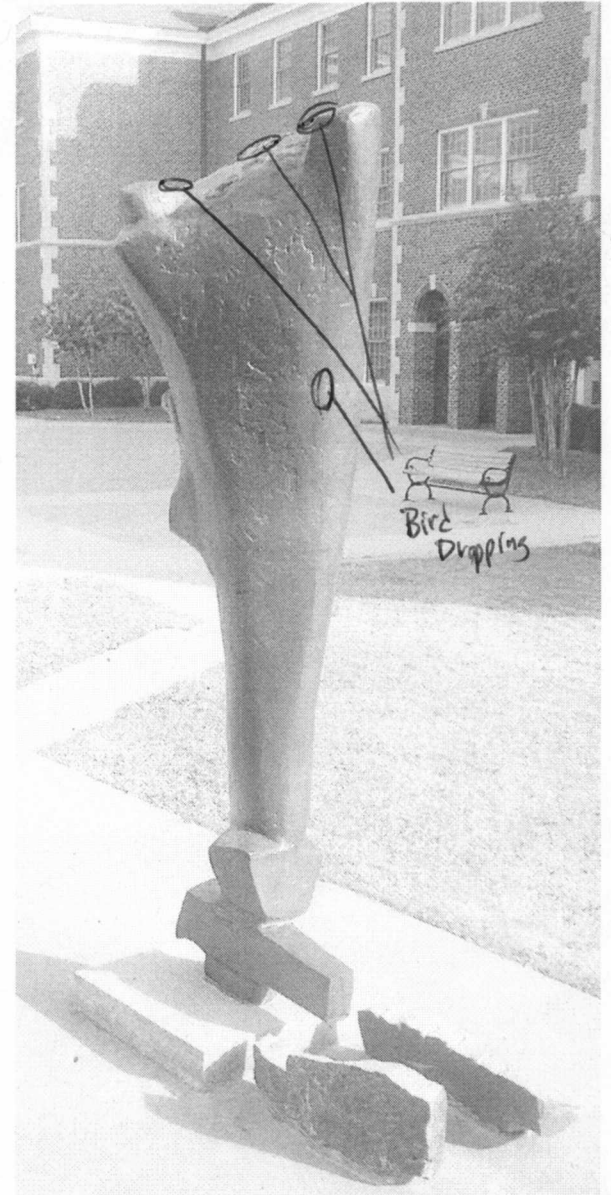
South West

Bird Droppings

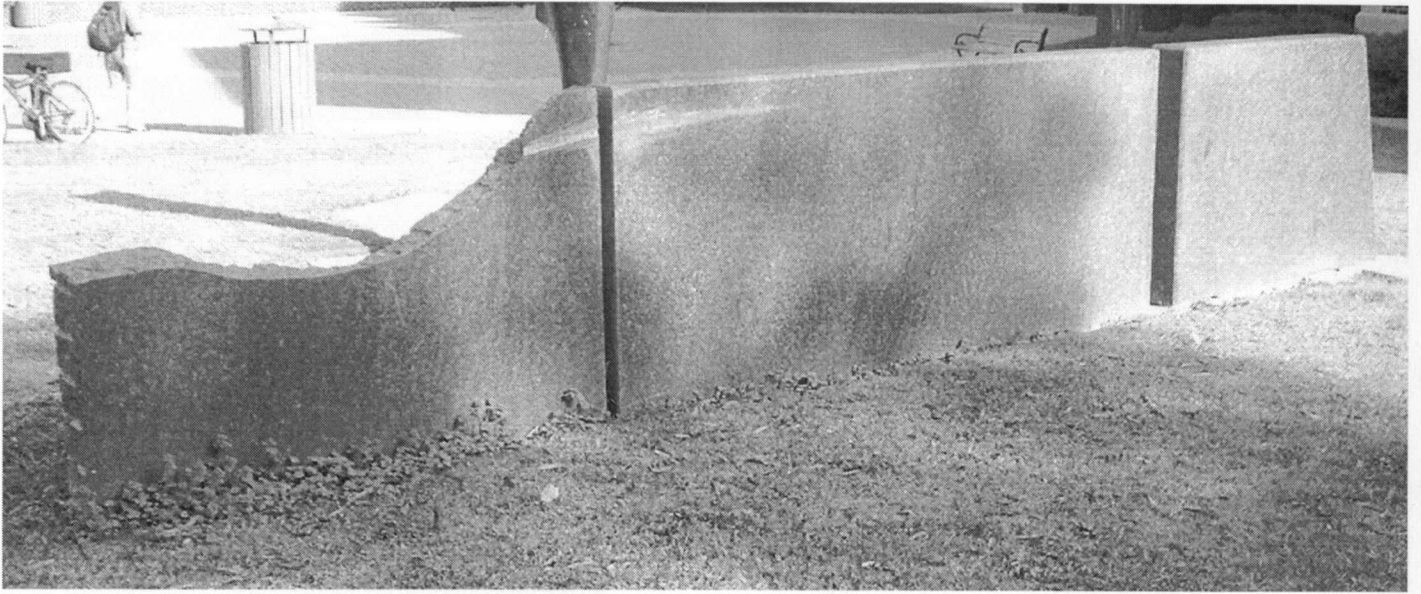
South No New signs of damage
