SCULPTURE MAINTENANCE RECORD

Title: Song of the Earth
Painted Steel

Location: ~~17A~~ Irby Hall, Conway, UCA

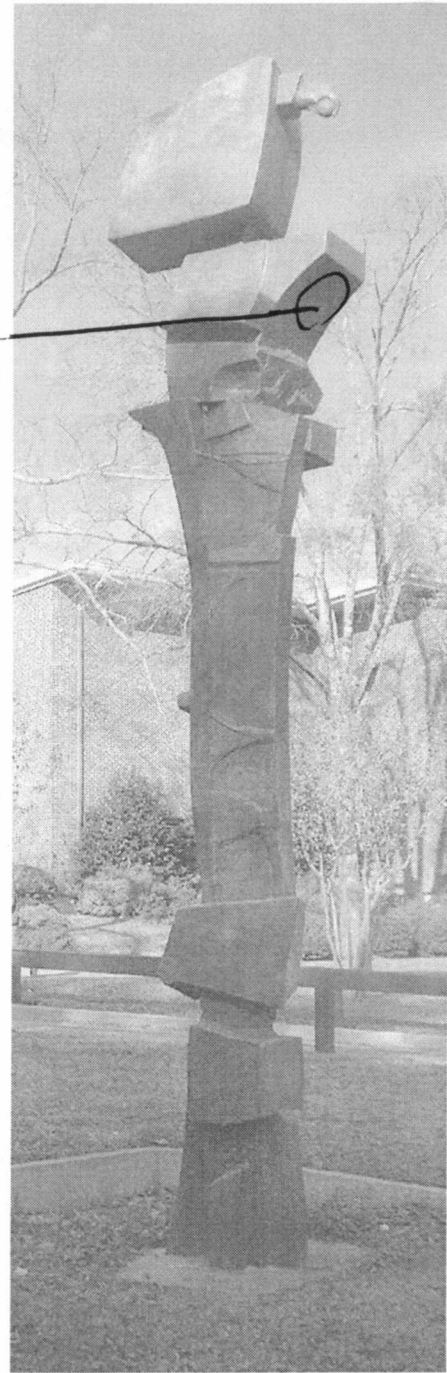
South East

chipped paint
rust spot

Spider
webs

Water
marks

Applies 2 coats of Johnsons Paste Wax, then buffed

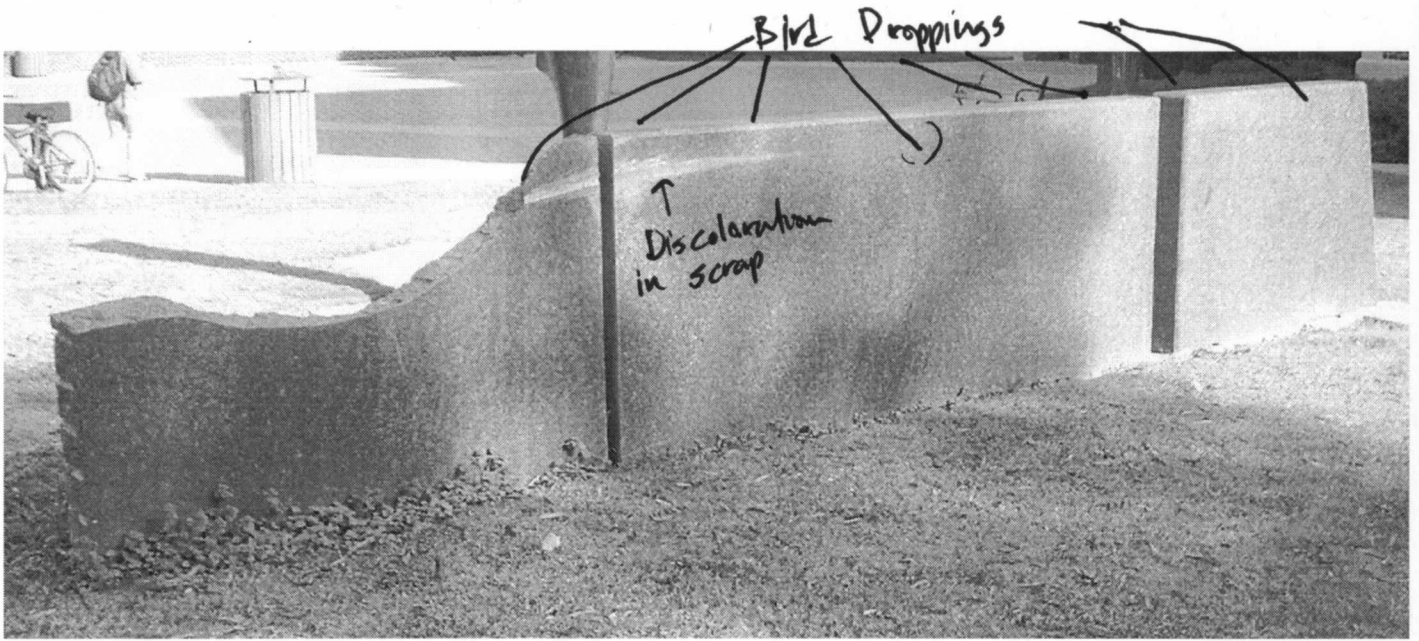
South

Dirty around base - from weed eating and mowing.
