SCULPTURE MAINTENANCE RECORD

Accession Number:			6	Bunnze
Artist:	Tom Gibbs	Title:	SONG OF THE EARTH Cast	Drawe
Location:	UCA, Conway	Component/Mate	erials:	
Dimensions:				
Date Examined: \\/	22/05	By (name): Rold	by Burton	
Date(s) of Maintenance	e Treatment: 11/22/05	By (name): Rold By (name): Rold		
Previous Maintenar (Indicate method and	nce Treatment: none materials used, if known)	☐ maintained (last date	Page 1 of 2	
CONDITION SCULPTURE				
☐ Discoloration (sta	aining, blanching, darkening)	□ Fabric of Sculpture □ □ Applied Coating(s)	Surface Finish or Applied Patina	
□ Graffiti □Fa	ubric of Sculpture Surface	Finish or Applied Patina	☐ Applied Coating(s)	
None			INTENANCE STEPS	
□ Corrosion Activity None	ty □Fabric of Sculpture	☐ Surface Finish or Applied	Patina	
□ Foreign Materials See diagro	s (accretions, bird guano)			
□ Physical Damage Nove	(worn, abraded, chipped, scratc	hed) □Fabric of Sculptur □ Applied Coating(e □Surface Finish or Applied Pati (s)	ina

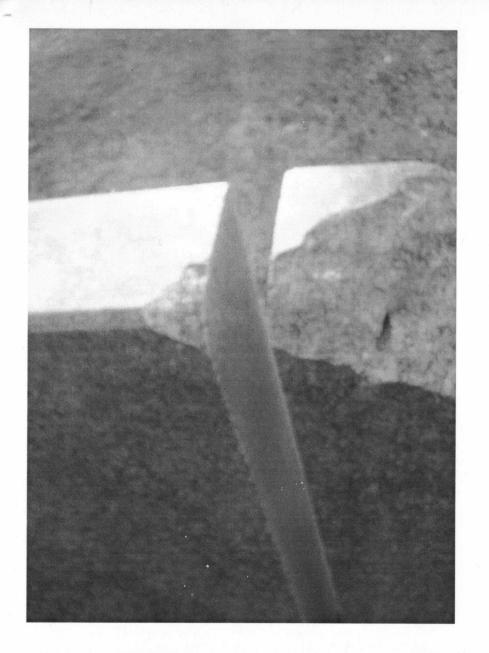
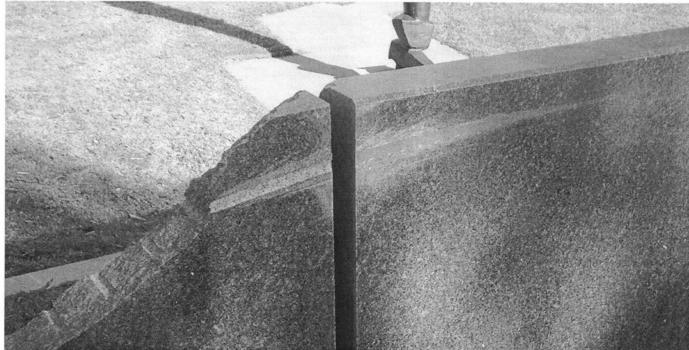
North

AINTENANCE RECORD		Page 2 of 2
Accession Number Artist/Title: Tom Date of Record:	Gibbs/SONG OF THE EARTH	Component:	
CONDITION PEDESTAL	see diagram retening wall seems to separation on the stairs	moving. There is also son	ne
☐ Graffiti	separation on the staur		
☐ Accretions			
☐ Staining			
☐ Mechanical Da			
☐ Cracks			
☐ Problems with	a Joints Frankland E3 avendund to arrow (C3 (e.gourse) beliege E3		
☐ Other Condition	on Problems		
3)	inish or Applied Patins D. Applied Coating()	Disabric of Sculpture Di Surface F	Etherið E
MAINTENANC	CE STEPS		
☑ Washed (Mai	terials/Method) Sculpture Pedestal		
Application of	of Protective Coating (Materials/Method)	☑Sculpture ☑ Pedestal	
☐ Other Mainte	enance Treatment Steps (Materials/Method	d) □Sculpture □ Pedestal
